CITY OF LAKE WORTH

ADA TRANSITION PLAN

May 19, 2016

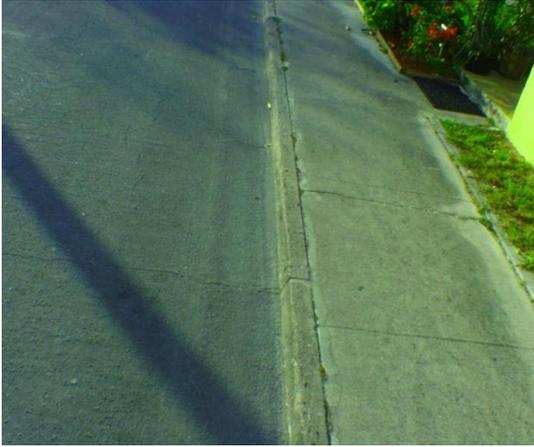
Figure 3-4: Sidewalk with a Crack; in need of Repair (3rd Ave S). ADA, 2010

The condition of the existing sidewalks was assessed to determine where repair or replacement of any of the existing sidewalks is necessary. Generally, a crack in the concrete can be repaired by milling the surface level and filling the crack. Sections with more substantial or numerous cracks were identified as needing to be replaced.

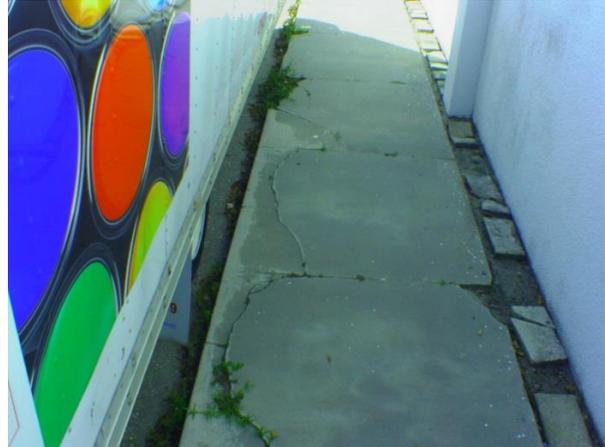
Figure 3-5: Sidewalk with Significant Cracks; in Need of Replacement (2nd Ave S). ADA, 2010

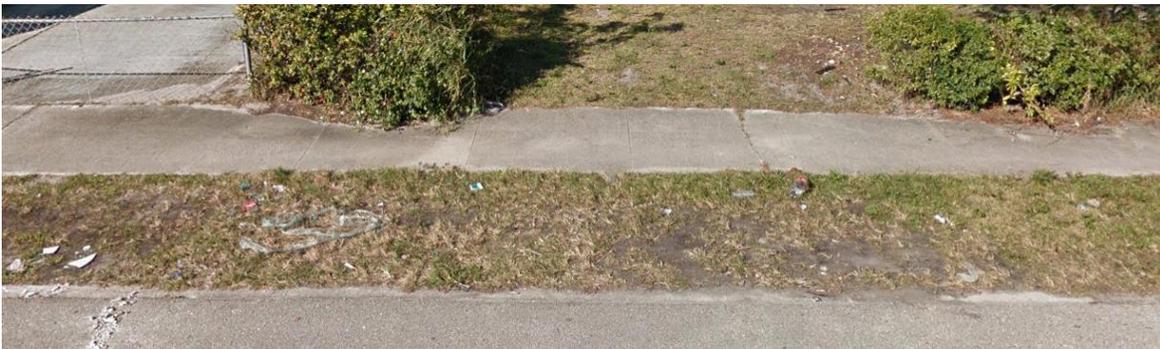
Figure 3-6: Sidewalk in Partially Good Condition and in Need of Repair (1332 S G St). Google Earth

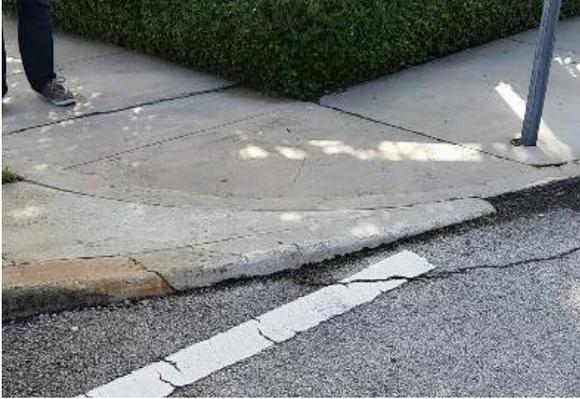
Figure 3-13: Missing curb ramp, verified in-field (1st S and Golfview, SW)

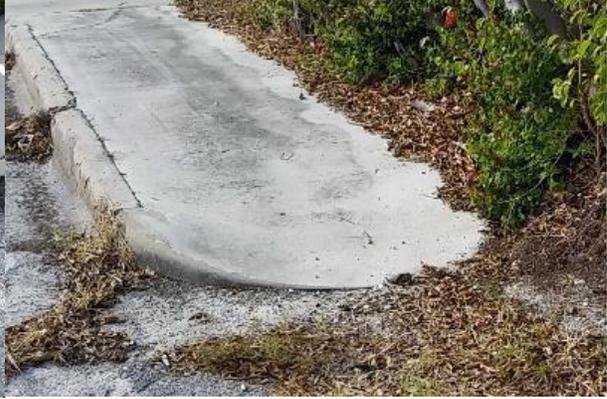
Figure 3-14: Field verified as too narrow, and non-compliant longitudinal slope with missing detectable warning (5th N and O, NW)

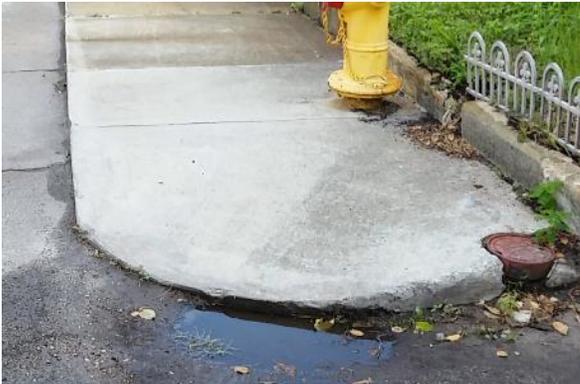
Figure 3-15: Field verified as uneven with a compliant longitudinal and cross-slope and a missing detectable warning (4th N and Federal, SE)

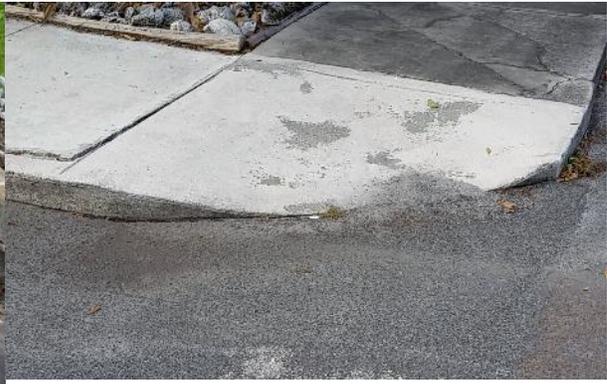
Figure 3-16: Field verified as non-compliant cross and longitudinal slopes with a missing detectable warning. (4th N and Palm Way, NW)
