CITY OF LAKE WORTH

ADA TRANSITION PLAN

May 19, 2016

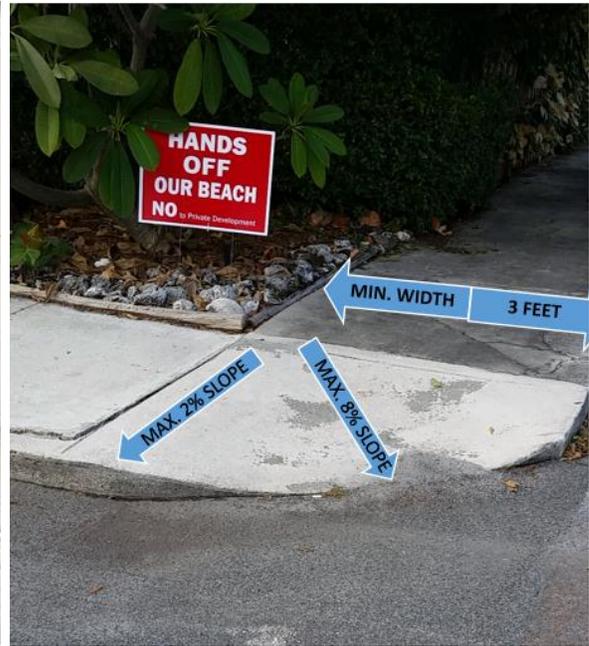
Figure 3-1 shows the criteria for a sidewalk with a point obstruction of less than 24 inches (in this case, a utility pole) in the accessible route. The minimum width in this situation is reduced from 36 to 32 inches. **Figure 3-2** shows a non-compliant curb ramp where the cross slope in the accessible route is too great as the route turns the corner.

Figure 3-2: Curb Ramp Criteria at a Corner Ramp

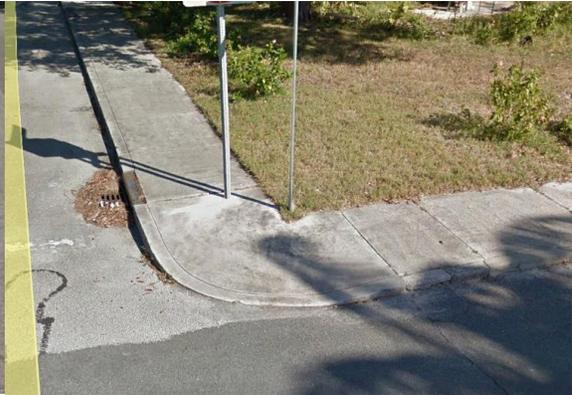
Figure 3-8: Non-Compliant Longitudinal Slope (7th N and O, NE). Google Earth

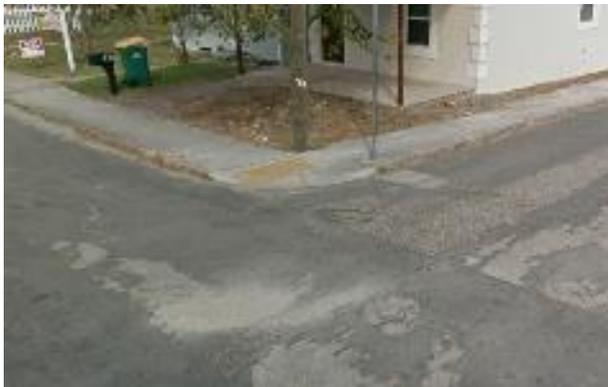
Figure 3-9: Non-Compliant Cross Slope (4th S and E, NW). Google Earth

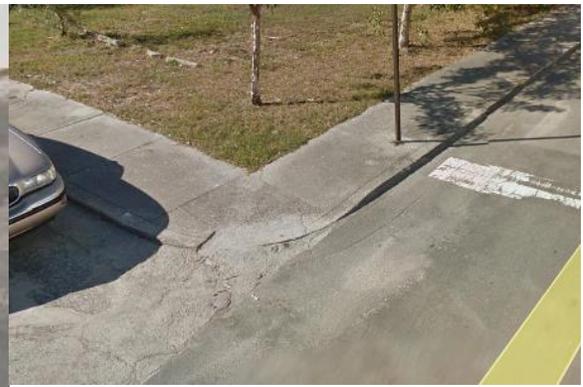
Figure 3-10: Non-Compliant Cross Slope and Non-Compliant Longitudinal Slope (5th N and K, SW). Google Earth

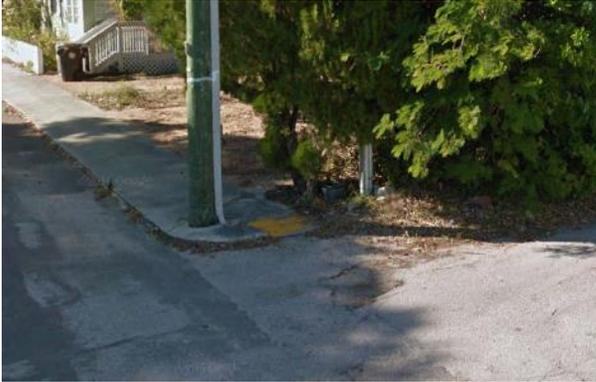
Figure 3-11: Non-Compliant Curb Ramp Width (1st S and M Aly). Google Earth

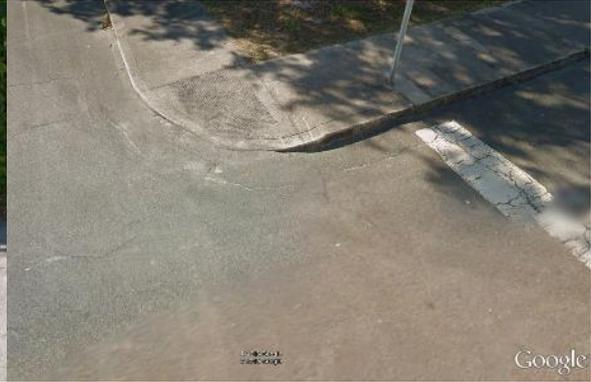
Figure 3-12: Non-Compliant Detectable Warning--Color and Material (5th N and L, SW). Google Earth
